CASE STUDY

RENOLD HYDROSERVICE CHAIN

Transmission Chain Comparison: Renold Vs Competitor

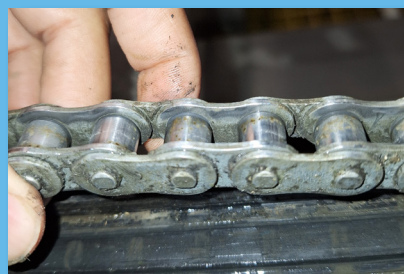
Renold's HydroService chain is currently showing no signs of corrosion.

Renold HydroService chain

Renold Hydroservice provides better corrosion protection compared to our competitor's chain. It offers 30x the corrosion protection of any conventional surface treatments and is hexavalent chrome free, which assists in providing a longer lasting product.

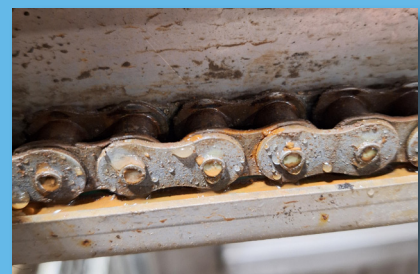
Our competitor's chain and Renold HydroService were both installed and commissioned in December 2024. Both have been in service for 3 months. Competitor's chain was found to have excessive wear and corrosion, resulting in elongation.

Competitor chain
